THE AQUATIC PLANT COMMUNITY OF CROOKED LAKE, ADAMS COUNTY

**Presented by Deborah J. Konkel
Wisconsin Department of Natural Resources
Eau Claire, Wisconsin**

2006

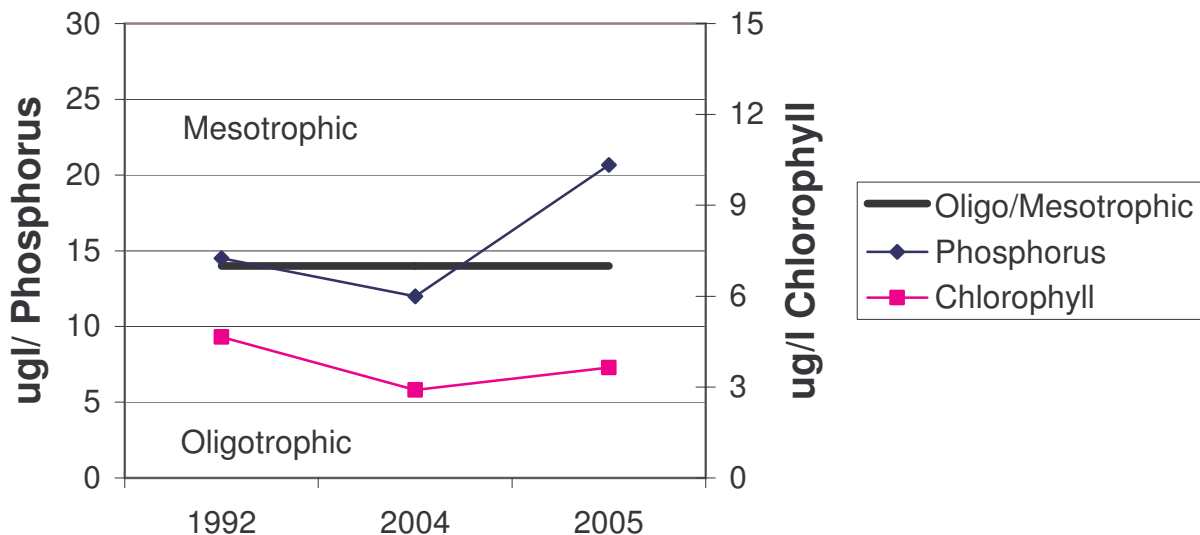
Figure 1. Variation in chlorophyll a and phosphorus concentration in Crooked Lake, 1992-2005.

Water quality was sampled in Crooked Lake by the DNR in 1992 and Adams County Land Conservation staff in 2004 and 2005. The sampling has not been conducted long enough or frequent enough to reveal trends. Chlorophyll (algae) and water clarity have varied within the oligotrophic range (Figure 1, 2) during the years sampled. Phosphorus (nutrients) has varied between oligotrophic and mesotrophic (Figure 1). Much of the nutrients may be going into filamentous algae growth, resulting in better water clarity and lower chlorophyll than would be predicted based on nutrient concentration.

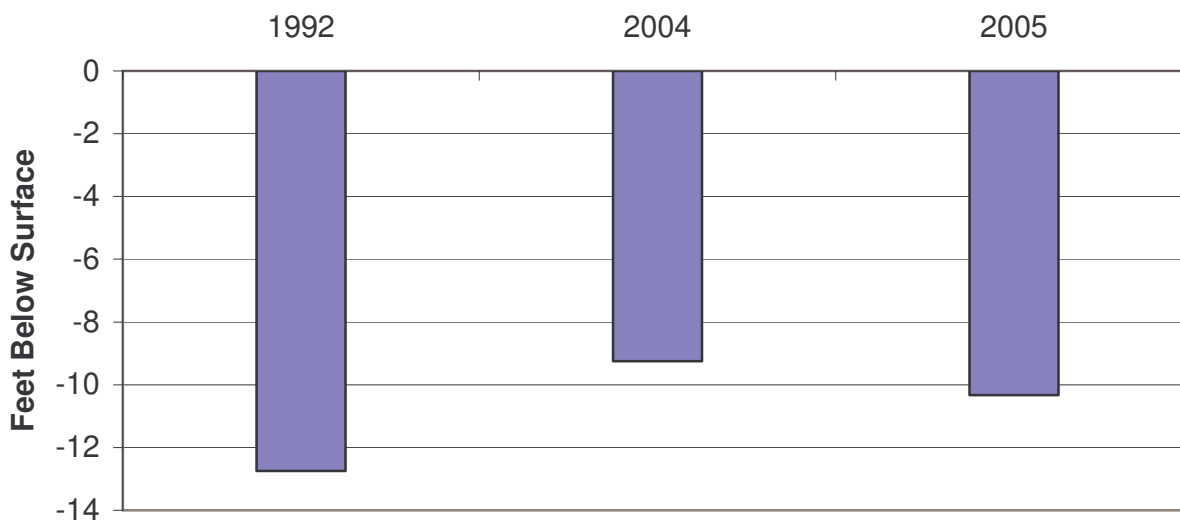
Figure 2. Water clarity in Crooked Lake, 1992-2005.

2004 Mean Summer Secchi Disc clarity in Crooked Lake was 10.3 ft.

Water clarity indicates (Table 1) that Crooked Lake was an oligotrophic lake with very good water clarity.

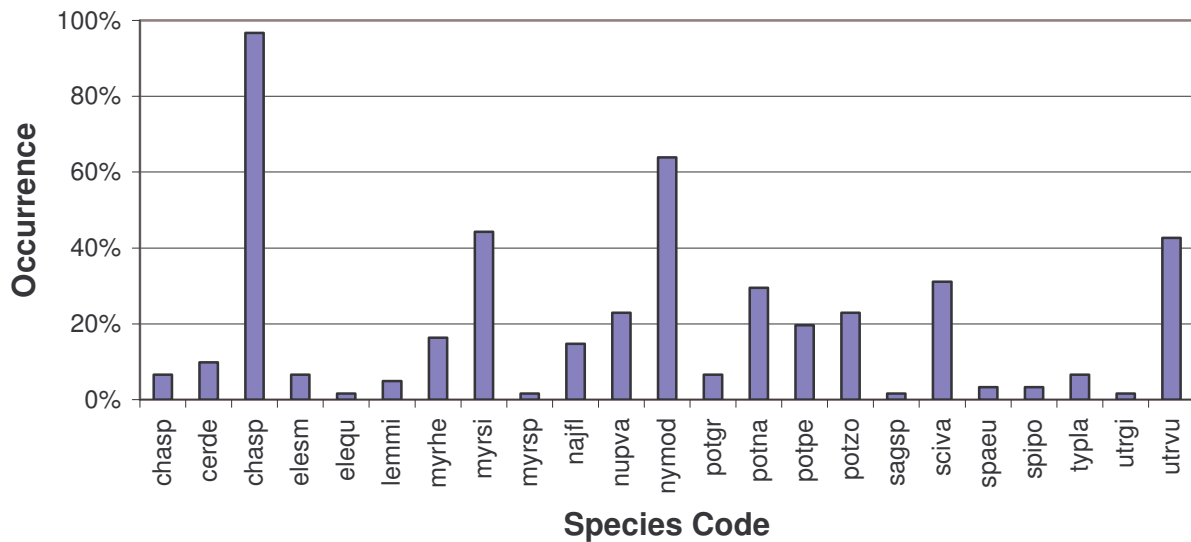
Figure 4. Frequency of occurrence of aquatic plant species in Crooked Lake, 2005.

Chara spp. was the most frequently occurring species in Crooked Lake in 2005, (97% of sample sites) (Figure 4). *Myriophyllum sibiricum*, *Nuphar variegata*, *Nymphaea odorata*, *Potamogeton natans*, *P. zosteriformis*, *Scirpus validus* and *Utricularia vulgaris* were also commonly occurring species, (44%, 23%, 64%, 30%, 23%, 31%, 43% respectively).

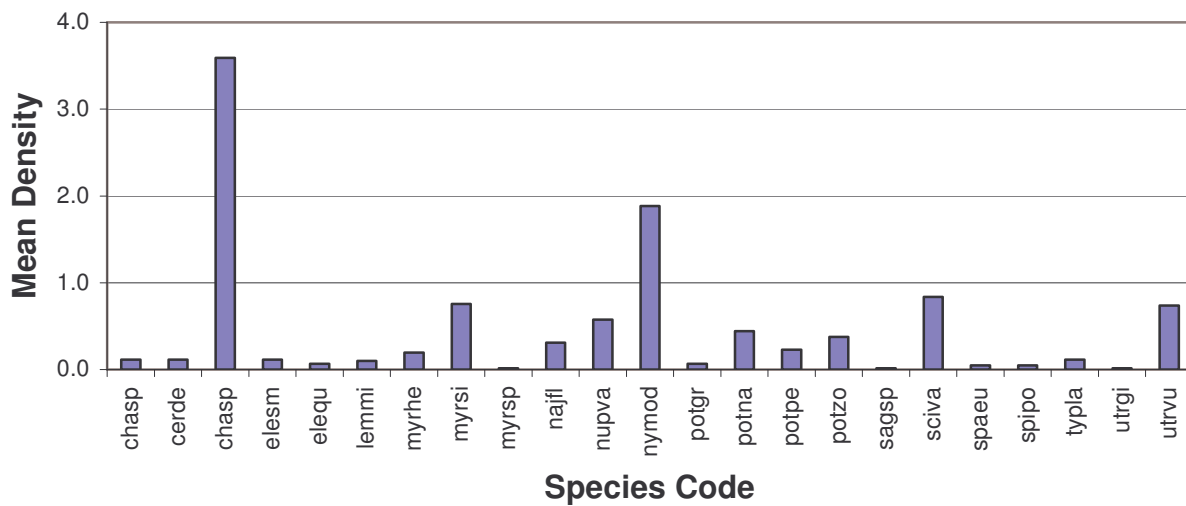
Figure 5. Mean density of aquatic plant species in Crooked Lake, July 2005.

Chara spp. was also the species with the highest mean density in Crooked Lake (3.59 on a density scale of 0-4) (Figure 5).

Chara spp. had a “mean density where present” of 3.71 (Appendix II). The “mean density where present” indicates that, where *Chara* occurred, it exhibited a dense growth form in Crooked Lake. *Eleocharis quadrangulata*, *Nymphaea odorata* and *Scirpus validus* also had “densities where present” of 2.5 or more, indicating that they also exhibited an aggregated growth form or a growth form of above average density (Appendix II). However, *E. quadrangulata* was aggregated in only one area in Crooked Lake and was not commonly occurring.

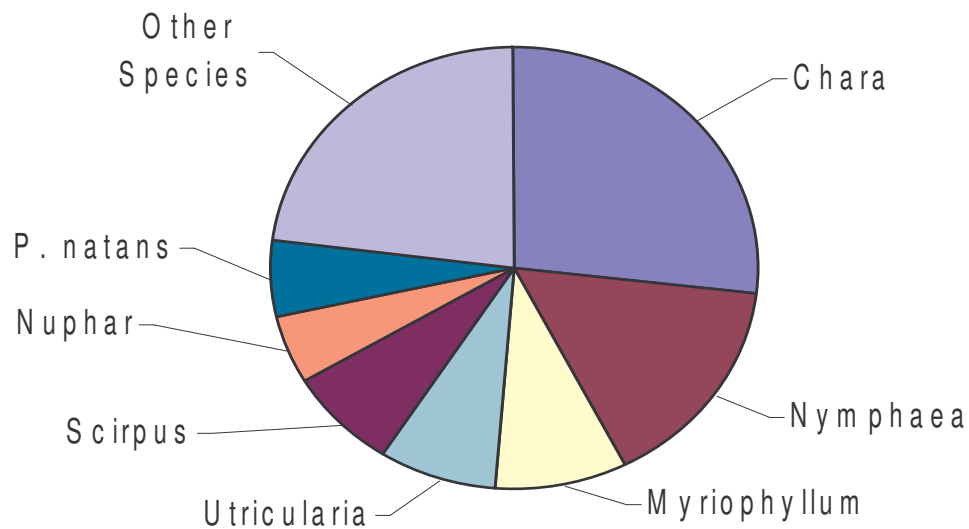
Figure 6. Dominance within the aquatic plant community, of the most prevalent plants in Crooked Lake, 2005.

Combining the relative frequency and relative density of a species into a Dominance Value illustrates how dominant that species is within the aquatic plant community (Appendix III). Based on the Dominance Value, *Chara* spp. was the dominant aquatic plant species in Crooked Lake (Figure 6). *Nymphaea odorata* was sub-dominant.

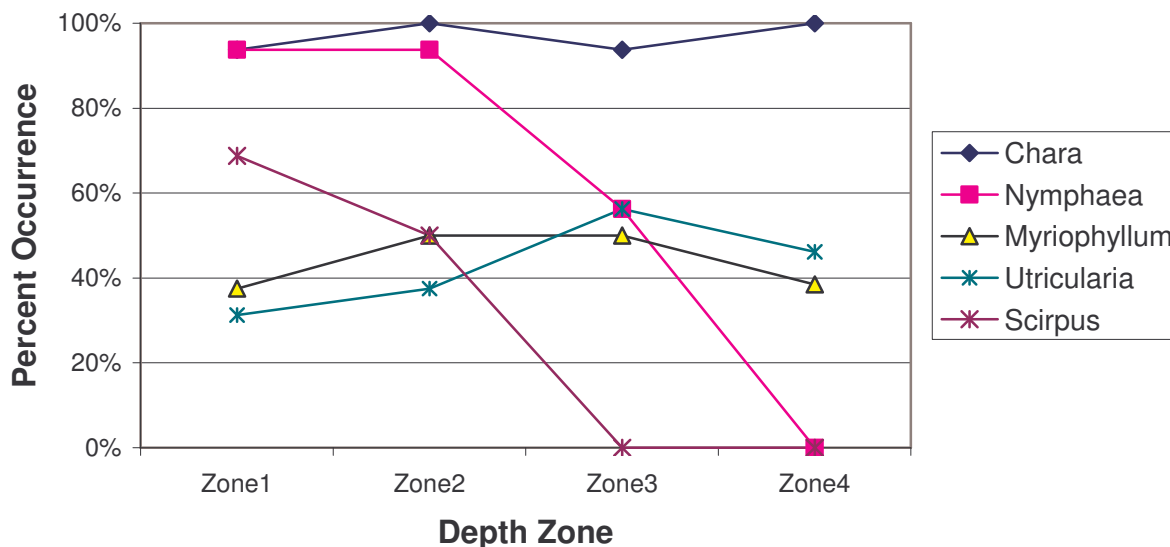
Figure 7. Frequency of occurrence of prevalent aquatic plant species in Crooked Lake, by depth zone, 2005.

Chara spp., the dominant species overall, dominated all depth zones. *Chara* occurred at its highest frequency and density in the 1.5-5ft depth zone (Figure 7, 8).

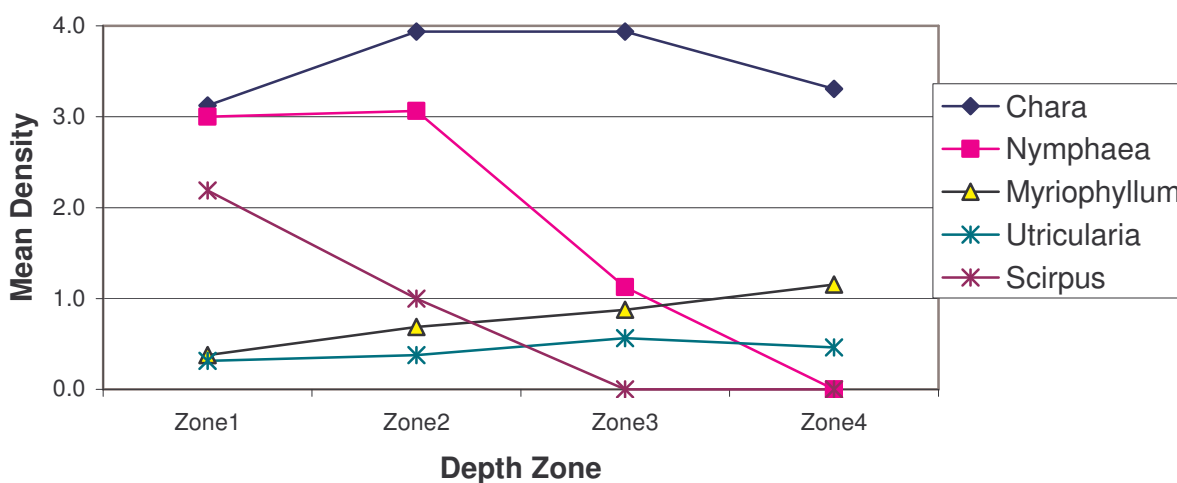
Figure 8. Density of prevalent plant species in Crooked Lake by depth zone, 2005.

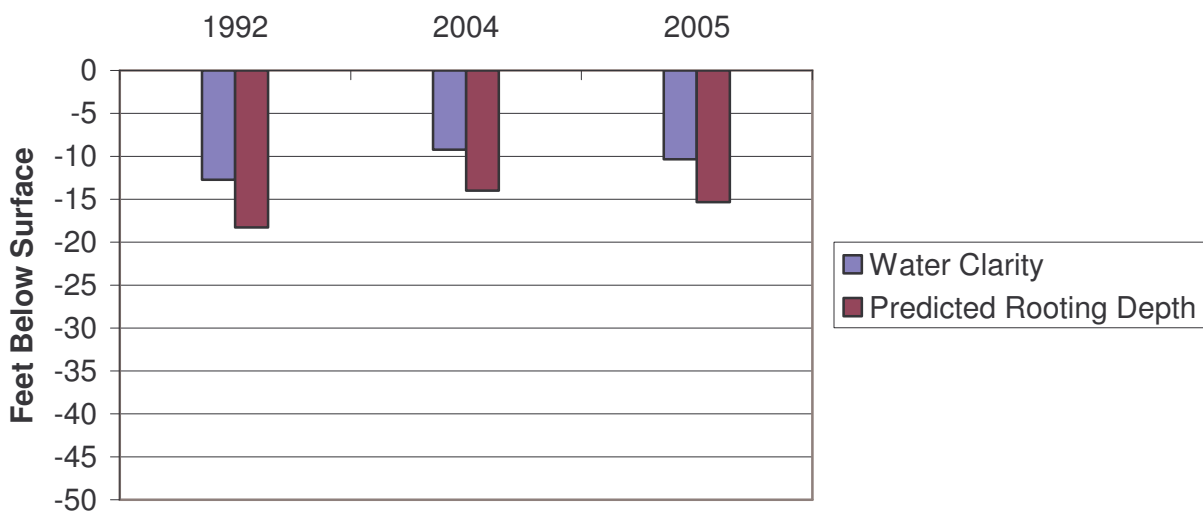
Figure 11. Predicted maximum rooting depth based on water clarity, 1992-2005.

Secchi disc water clarity data can be used to calculate a predicted maximum rooting depth for plants in a lake (Dunst 1982).

$$\text{Predicted Rooting Depth (ft.)} = (\text{Secchi Disc (ft.)} * 1.22) + 2.73$$

Based on the 2005 Secchi disc clarity, the predicted maximum rooting depth in Crooked Lake would be 15.3 ft.

The actual maximum rooting depth is less than the predicted maximum rooting depth based on water clarity for 2005 (Figure 11) and may be due to the steep littoral zone in the deeper areas of the lake. These steep slopes provide a less stable base for plant colonization.

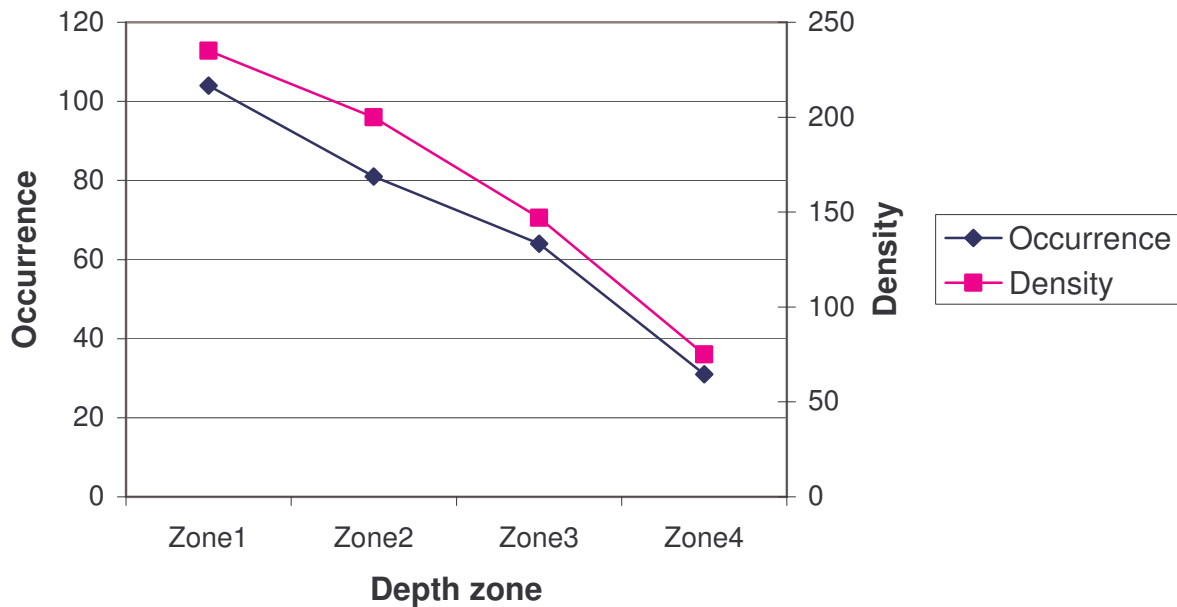
Figure 12. Total occurrence and total density of plants in Crooked Lake by depth zone.

The 0-1.5ft depth zone supported the greatest amount of plant growth. The highest total occurrence and total density of plant growth was recorded in the 0-1.5ft depth zone (Figure 12) and declined with increasing depth.

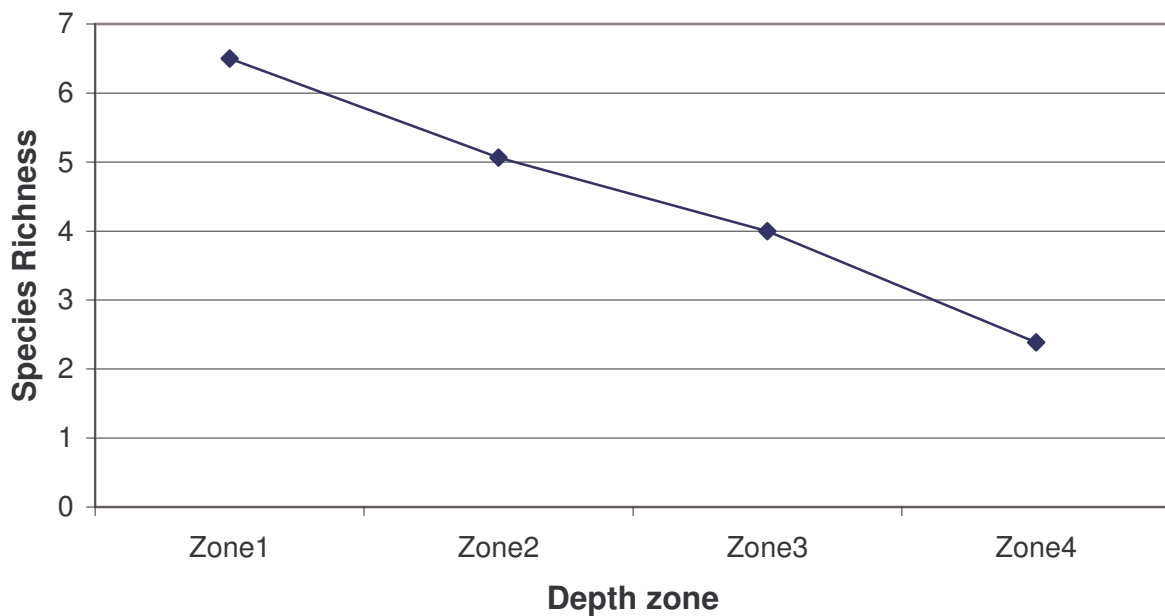
Figure 13. Species richness in Crooked Lake, by depth zone, 2005.

The greatest species richness (mean number of species per site) was also recorded in the 0-1.5 ft. depth zone (Figure 13), declining with increasing depth. Overall species richness in Crooked Lake was 4.6 species per site.
